DAMS & RESERVOIRS

Reference: CS-38

Selected Projects

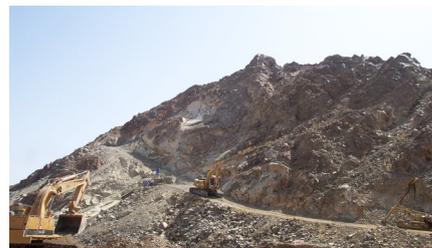
Case Study: Geotechnical assessment of dam abutment

Stability assessment of the right abutment to the main Hatta Dam above the centre line of the asphalt core (then under construction). A detailed structural geological survey was undertaken of the right abutment, highlighting the possibility of mass slope movements from un-restricted excavation. Design controls to ensure undercutting of critical joint and fault surfaces were put in place. Detailed slope designs ensured the hazards were successfully removed in a controlled manner ahead of raising the dam.

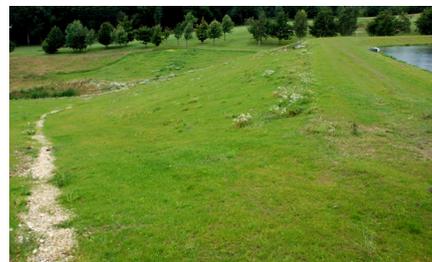
Case Study: Construction Quality Assurance (CQA) monitoring of lined dam and reservoir

Site investigation, design and Construction Quality Assurance (CQA) of a 9m high earth dam to form a 22,000m³ water feature and irrigation supply for a golf club. The design had to mitigate the running sands and sand lenses found during the site investigation, providing adequate drainage layers through the dam structure. The design included stability analysis and overflow design, whilst site monitoring ensured that the embankment dam was constructed to the correct specification.

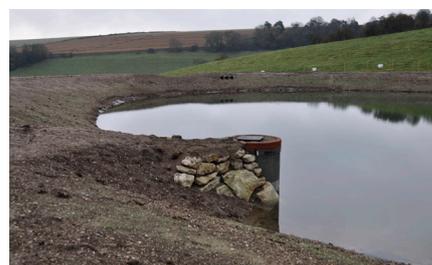
Case Study: Geotechnical Investigation and CQA

Geotechnical site investigation and CQA of a lake excavation and 7m high embankment dam construction for a proposed sporting lake in Wiltshire. Specification of HDPE liner, overflow pipes and spillway and geotechnical assessment of the proposed source material for embankment construction. Construction supervision was provided by a GWP engineer, throughout the construction operation comprising topsoil stripping, lake excavation and embankment dam construction.

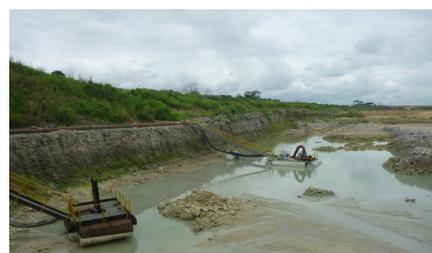
Case Study: Flood mitigation and dewatering feasibility assessment

Detailed design of flood alleviation and mitigation measures for 2 No. limestone quarries, as part of a multimillion dollar development in Nigeria. Rigorous hydrological analysis of rainfall events was undertaken to inform the design of 3 No. dams and 2 No. reservoirs. Specification of dam spillways and the required geotechnical investigations were undertaken, including stability analysis and design of appropriate drainage and overflow infrastructure.

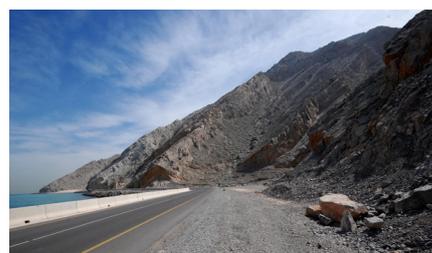
Case Study: Stability assessment and mitigation strategy

Assessment of slope failure and rockfall hazard along the Khasab to United Arab Emirates border coastal road corridor was undertaken in response to a heavy rainfall event triggering numerous large scale rockfall incidents along a 34km section of road. The area was structurally mapped to allow the relevant rock slope failure mechanisms to be determined to aid in design of appropriate mitigation strategies. Mitigation measures included consideration of installation of netting and rockfall traps, re-profiling the slope, tunnelling and causeway development.

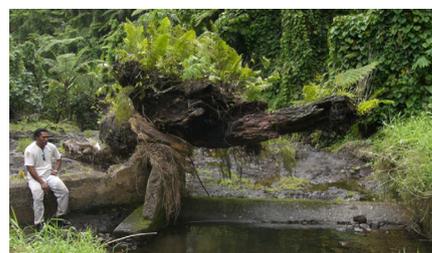
Case Study: Water resources management

A five year national water resources management and governance programme in Samoa, including the improvement of water resources protection and conservation, as well as the assessment and monitoring of surface water and groundwater resources. Watershed characterisation was undertaken to determine sediment mobilisation potential and assess cyclone risks posed to water management infrastructure, such as weirs, dams, spillways and reservoirs.
