GWP Experience in Small Islands Water Resources Management

Reference: CS-30

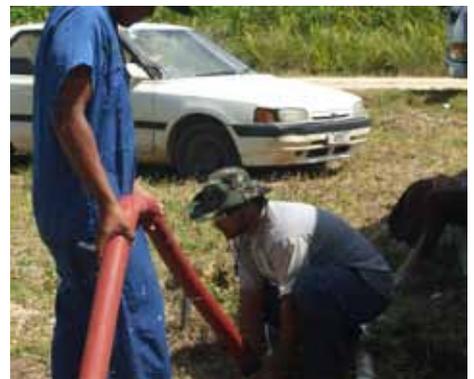
Groundwater Lens Vulnerability Assessments on Niue Island

Niue Island is an extensively karstified raised limestone atoll, with no surface water, and all villages supplied by boreholes, with unknown groundwater lens volume and drought vulnerability. GWP designed and supervised the construction and testing of 3 No. multi-level piezometer nest boreholes, enabling the freshwater lens thickness to be monitored using manual and automated systems. Production borehole pumping tests, surface geophysics, and a national well inventory contributed, with the new monitoring system, to establishing lens and borehole sustainable yields, drought and pollution vulnerability (from land use and post cyclone damage) assessments were delivered. Production borehole pumping tests, surface geophysics, and a national well inventory contributed, with a new monitoring system, to establishing lens and borehole sustainable yields.

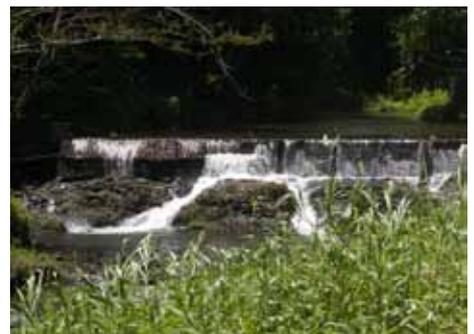
National Water Resources Assessment and Management for Samoa

Provision of a 5 year technical support programme, including national inventories of water resources, and institutional and legislative capacity needs assessments. The project designed and delivered surface water and groundwater monitoring systems, including flood warning and watershed management monitoring networks, identification of basin sustainable yields and saline intrusion vulnerability assessments, introduction of water allocation licensing, watershed rehabilitation initiatives and up-skilling of local staff.

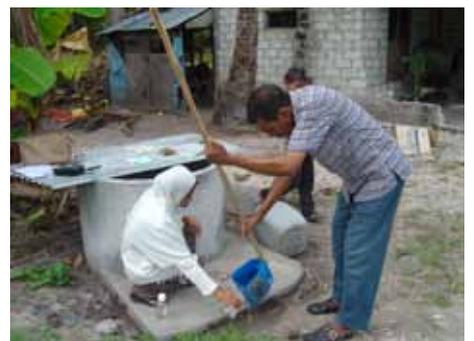
Tsunami Impact and Recovery Assessments for the Maldives

The Asian tsunami of December 2004 caused widespread devastation on the low-lying atoll islands of the Maldives, resulting in infrastructure destruction and widespread salinization of the groundwater resources. Rapid assessments of groundwater quality across the country were undertaken using pre-existing monitoring nests and augmented using surface geophysics and well surveys, to establish the groundwater salinization extent from tsunami inundation, as well as the speed of re-freshening of the freshwater lenses. These findings were used to re-design development agency recovery strategies.

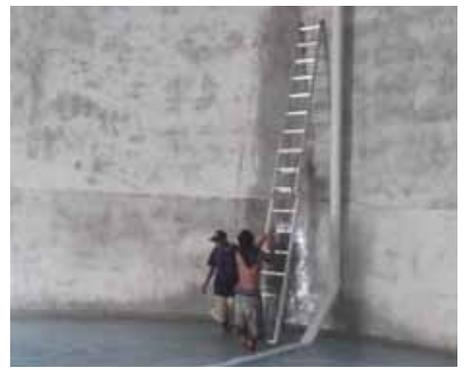
Urban and Rural Rainwater Harvesting Improvements in Kiribati

Rainwater harvesting assessments were undertaken on houses, communal buildings (churches & maneabas), and strategic infrastructure assets (hospitals and warehouses) to identify improvements required to increase drought resilience of target communities. Community consultations developed island wide water master plans. Detailed water supply designs, tender document preparation, procurement support and construction supervision were provided for water catchment refurbishment, transmission mains, pumping stations (where required) and storage and header tanks. Operation and maintenance and hygiene promotion guidance were also delivered.

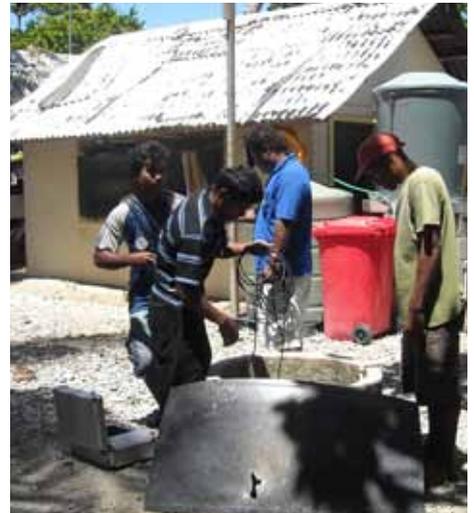
Groundwater Assessment and Exploitation in Kiribati

Island drought resilience can be significantly improved through exploitation of groundwater resources. 22 islands were assessed using well inventories, surface geophysics and piezometer nest drilling to identify fresh groundwater resources and establish sustainable yields. An infiltration gallery was designed and installed at a demonstration community to skim freshwater, utilising solar pumps and header tanks. Operation and maintenance and resource protection guidance were also delivered. Existing but abandoned urban groundwater infiltration galleries were rehabilitated, pump and head works infrastructure replaced, power supplies reinstated, transmission mains replaced and repaired as appropriate and security measures enhanced to protect the abstraction system.

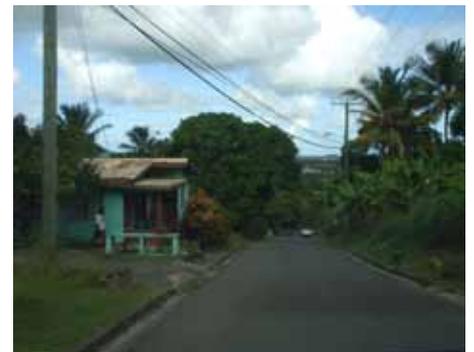
Caribbean Guidelines on Surface Water Re-Use and Groundwater Recharge

Rainwater and especially storm water run-off entering the sea are seen as both a lost freshwater resource and a flood and erosion hazard. This project explored different rainwater and storm water capture and disposal technologies to enhance groundwater recharge. Guidelines were developed across a range of scales from individual households, to communal buildings, to major developments and sub-catchments and watersheds, using hard engineering and soft eco-system infrastructures, for a variety of water types including rainwater, storm water run-off, river waters, greywater and blackwater.

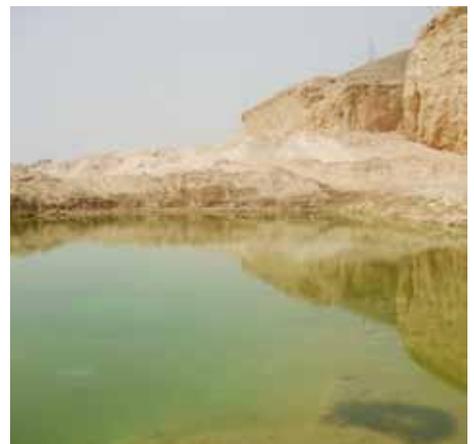
Storm Water Control and Management on Zirqa Island, United Arab Emirates

Intense storm events in small steep catchments create rapid flood flows capable of intense destruction to infrastructure and communities. Ungauged wadi catchments were characterised on an offshore island and then assessed for appropriate return period rainfall events to determine times-to-peak and peak flood flows discharging through and around a proposed multi-million dollar oil installation facility. Existing storm water designs were checked and re-designed to provide an effective spate flood management drainage system.
